Ettringite as a factor causing structural strengthening of fluvial sand from the Praski terrace (Warsaw, Poland)

Zawrzykraj, P., Rydelek, P., Bąkowska, A. and Cabalski, K. 2022. Ettringite as a factor causing structural strengthening of fluvial sand from the Praski terrace (Warsaw, Poland). *Acta Geologica Polonica*, **72** (4), 519–528. Warszawa.

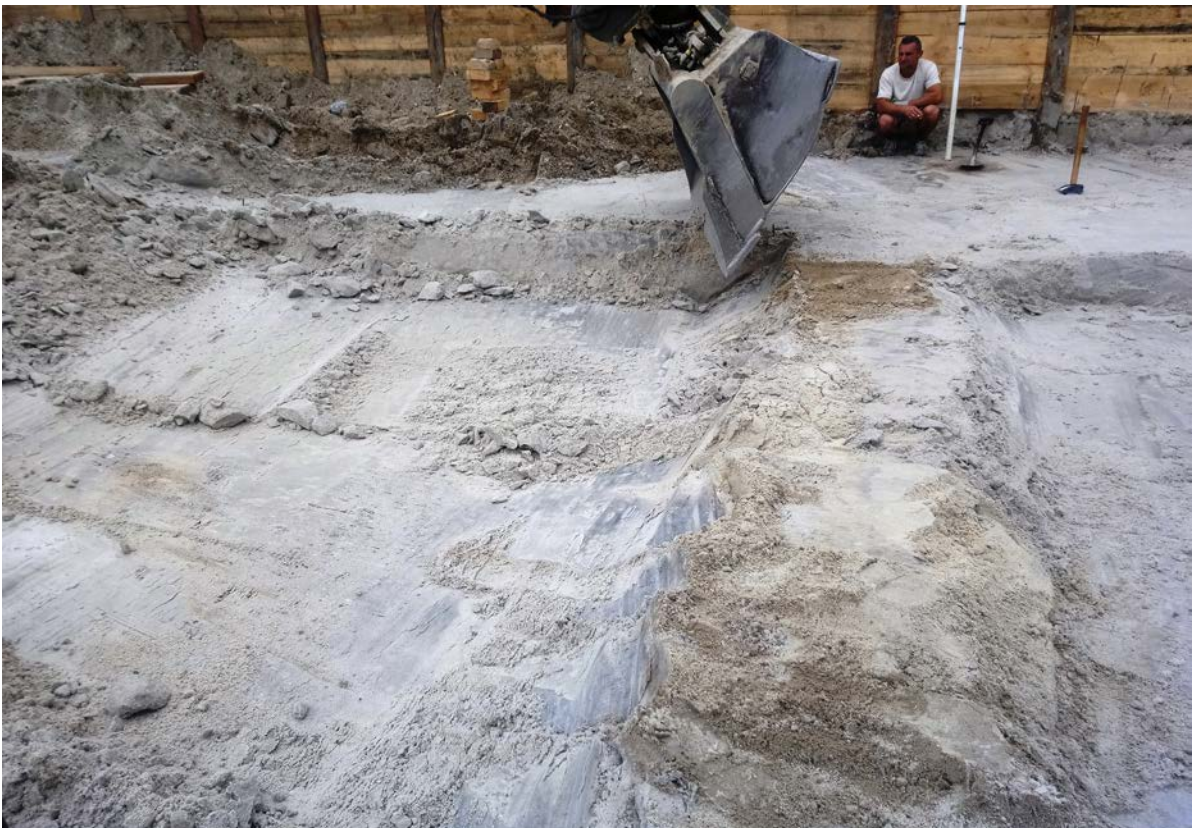
Text-fig. 6. Unnatural grey colour of cemented fluvial sand (originally yellow in colour) forming blocks and crumbs during mining. Picture taken at point c4 (as located in Text-fig. 1).

During fieldwork in June 2018 unusual soil changes were observed at the bottom of the trench excavation (Text-fig. 5). These changes were manifested in a macroscopically visible colour change and cementation of fluvial sand (Text-figs 6, 7).

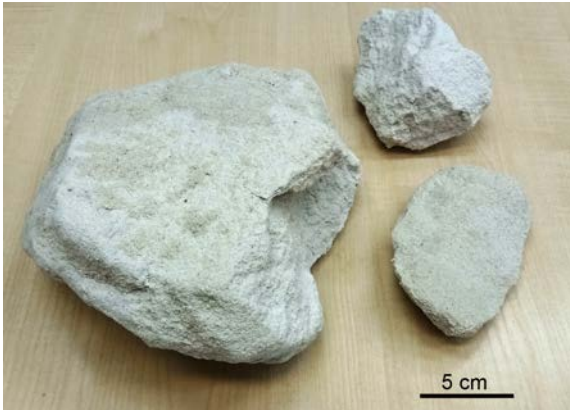
Text-fig. 7. Samples of cemented fluvial sand collected for laboratory tests (air-dry condition).
