Andrzej Karol TEISSEYRE*

FLUVIAL PROCESSES ON THE WET MISZKOWICE FAN. PART I: EROSION AND EROSIONAL LANDFORMS

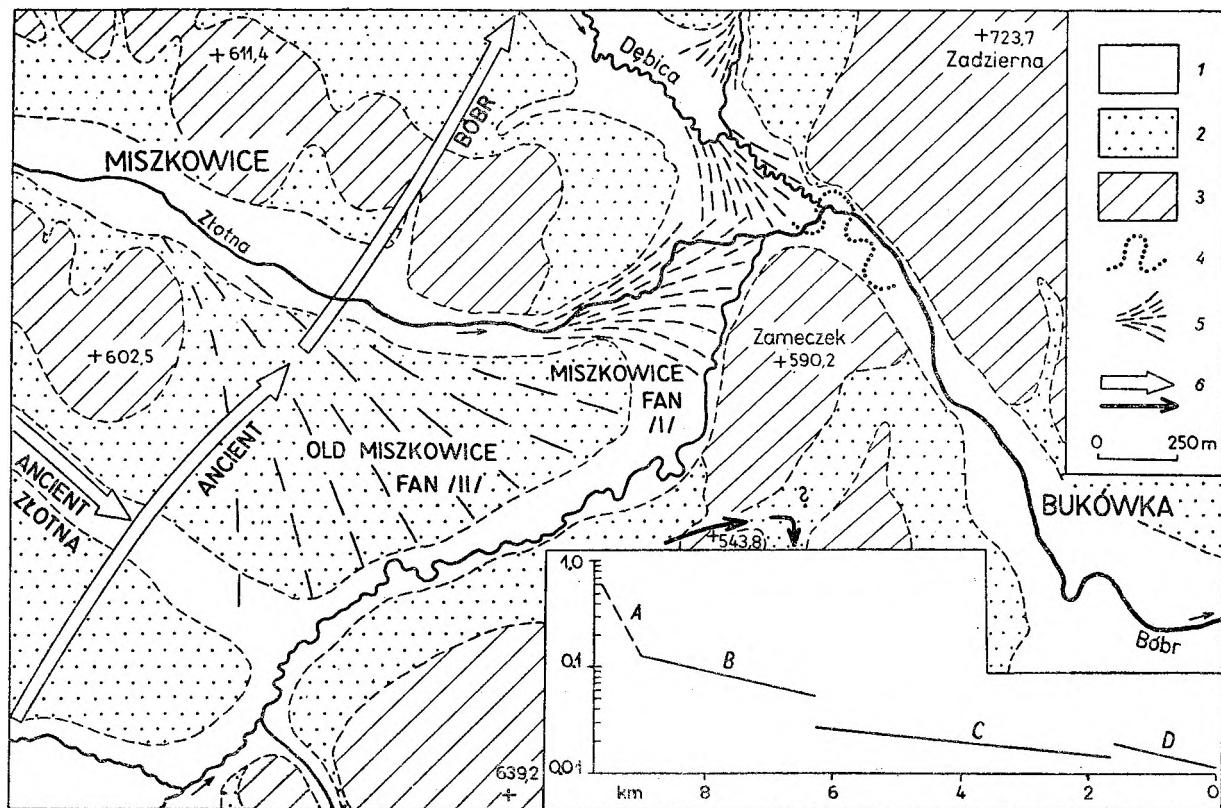
Fig. 2

Geologic sketch-map of the Miszkowice Fan. Inset shows longitudinal profile of the Złotna (distance on abscissa, slope on ordinate)
 1 – alluvia (Holocene); 2 – slope deposits; colluvia and older alluvia (Pleistocene– Holocene); 3 – bedrock (Lower Carboniferous); 4 – meandering channel of the River Bóbr prior to regulation; 5 – alluvial fans; 6 – ancient river courses

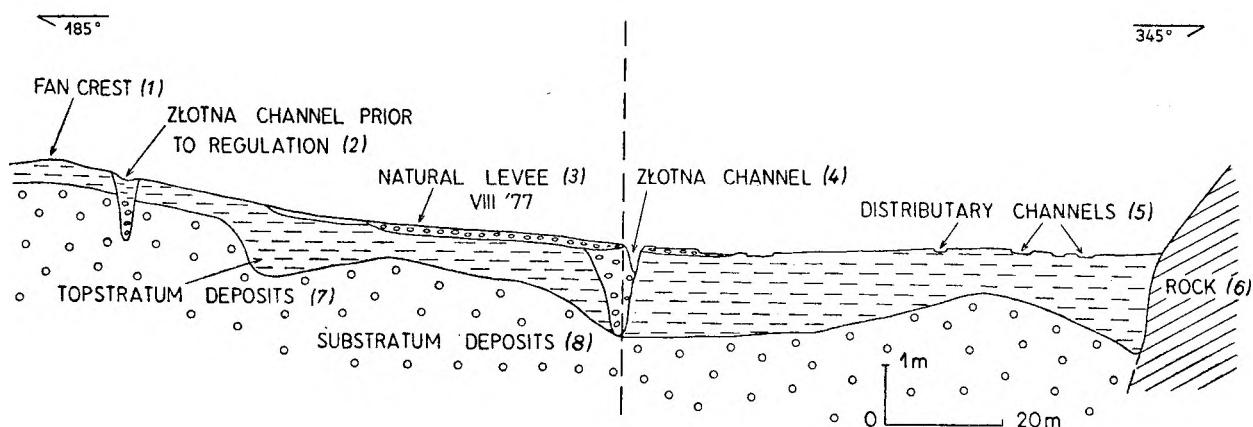
Fig. 3

Cross-section through the central portion of the Miszkowice Fan. Levelling is by the author (August 1978)

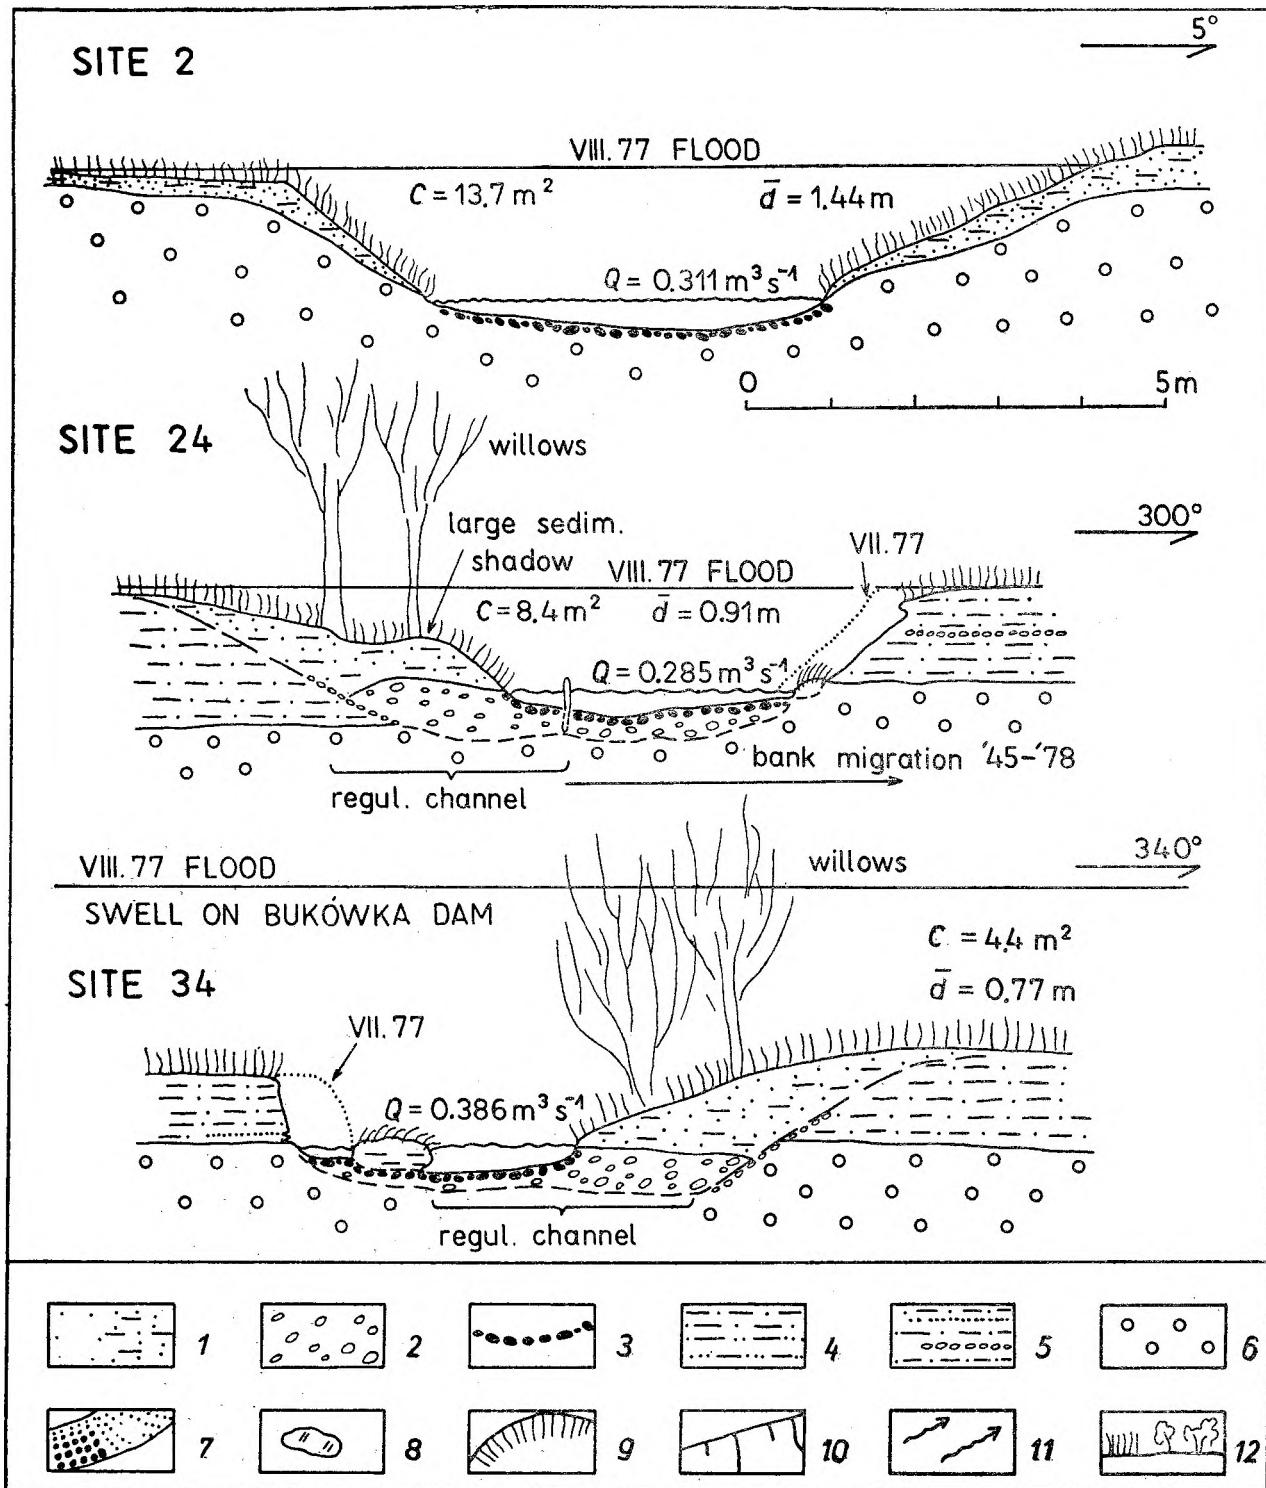
Fig. 4

Cross-sections through the artificial channel of the lower Złotna, Miszkowice Fan. See figure 5 for location. No vertical exaggeration. All the cross-sections in the paper are looking upchannel. C — channel capacity, \bar{d} — mean depth

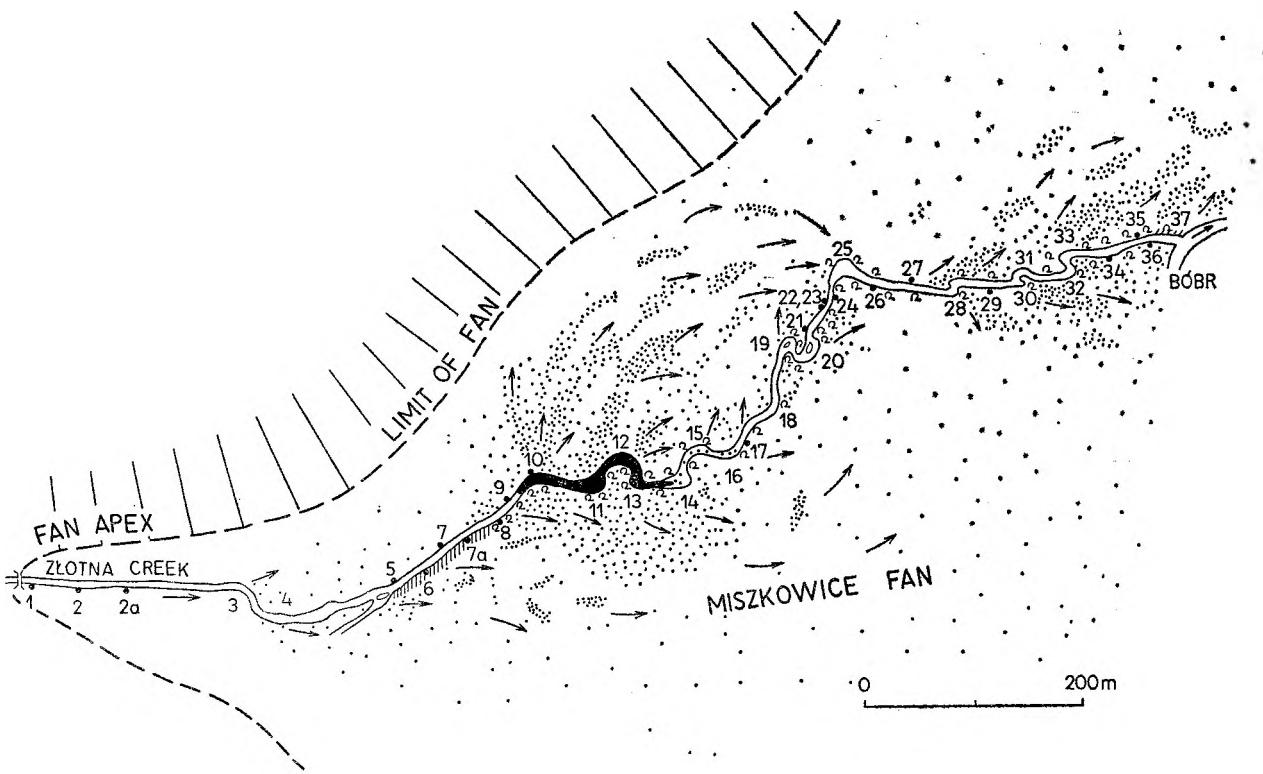
Fig. 5

Sketch of the lower Złotna on the Miszkowice Fan showing location of sites described in the text

August 1 to August 2. Except for the fan-head area (between sites 1 and 3, fig. 5) the flow was everywhere overbank and a large part of the fan was beneath water (pl. I, 2–4). The fan-base segment was covered by standing water swelled on the Bukówka Dam. The discharge fell rather rapidly and on August 2 a large part of the fan has emerged. Since August 2 the discharge was less than bankfull below site 13. However, till the end of October the discharge was greater than mean (fig. 1) and a substantial rise was noted on August 23, after a heavy summer rain on August 22 (51.1 mm rainfall at Lubawka).

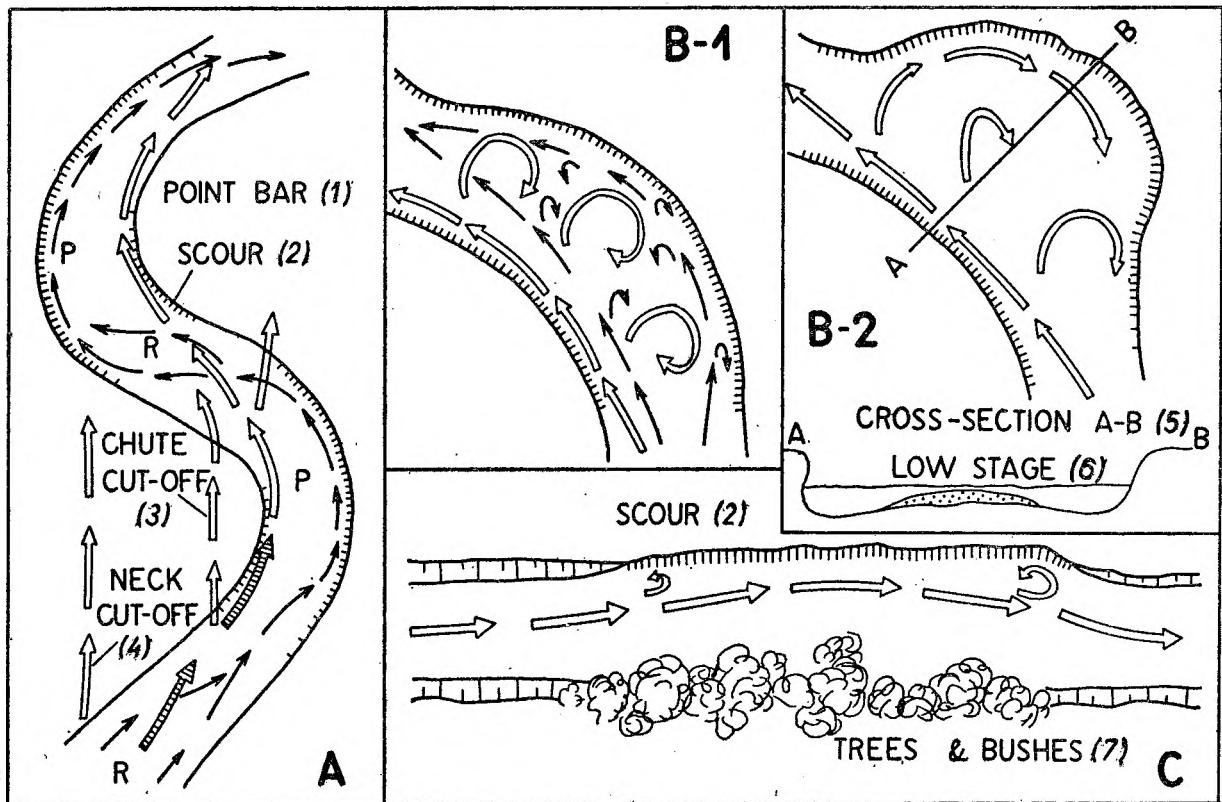
Fig. 6
Lateral erosion in alluvial channels (diagrammatic drawings)

Arrows indicate streamtubes of maximum velocity at low discharge (light arrows) and in flood (solid arrows). P — pool, R — riffle. See text for explanation

The position of the streamtube of maximum velocity in channels observed by the author is shown diagrammatically in figure 6 (it was too dangerous to make levelled profiles during the floods). Changes in position of the streamtube of maximum velocity in meander bends are illustrated in figure 6A. During a flood discharge the streamtube of maximum velocity tends to bifurcate or trifurcate over the point bar with either the neck-or chute cut-off as a result (cf. Hickin 1969; Bridge 1975; Baker 1977; A. K. Teisseyre 1977a). Figures 6B-1 and 6B-2 demonstrate a flow pattern in pseudomeanders (cf. Wolman and Brush 1961). During a flood discharge supercritical flow occurs at the inner bank which is intensely scoured. At the same time a very strong backflow circulation occurs at the outer cutbank giving rise to the formation of a large bank niche (fig. 6B-2). The backflow velocity is not uncommonly up to 70% the co-flow velocity. Thus the following features can be thought to be characteristic of pseudomeanders (pl. II):

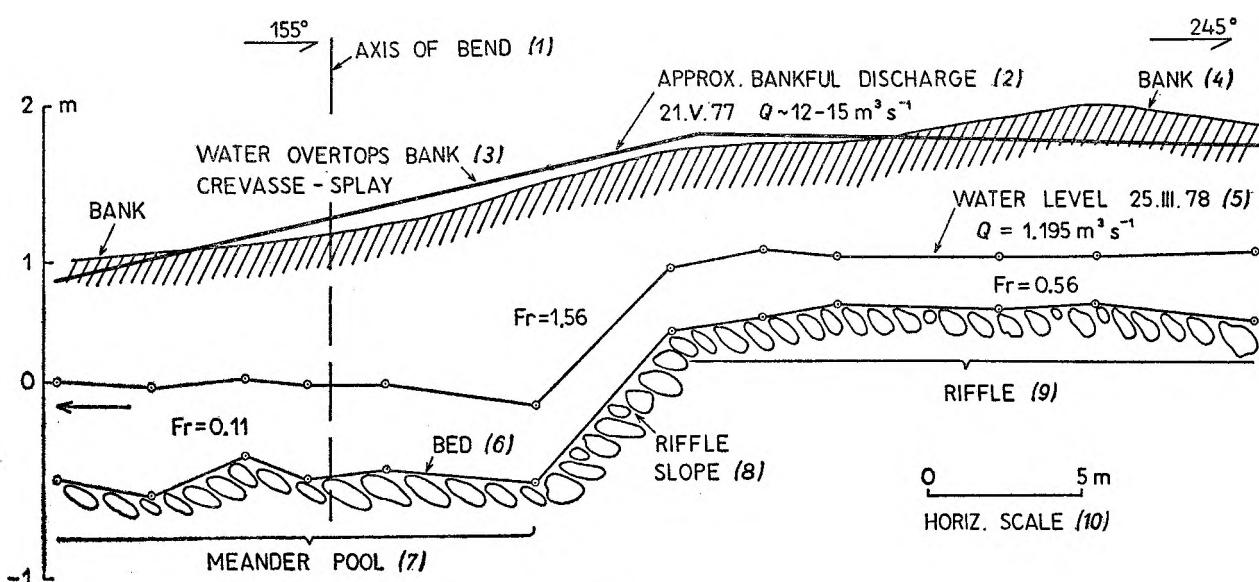
Fig. 7

Flood discharge overtopping the outer cutbank of a meander bend as a consequence of flow perturbation in the bend, lower Złotna, site 32. Levelling is by the author

Genetically, downward erosion is brought about by processes of turbulence similar to those described above (see fig. 7, 8, 11). Field observations and measurements have revealed that downward erosion is as a rule accompanied by lateral erosion though the reversal is not always true. Generally, the largest lateral retreats of the outer cutbanks have been noted close to the deepest pools but many exceptions to this rule have been found (in pseudomeanders, bank niches and some riffle segments, for instance).

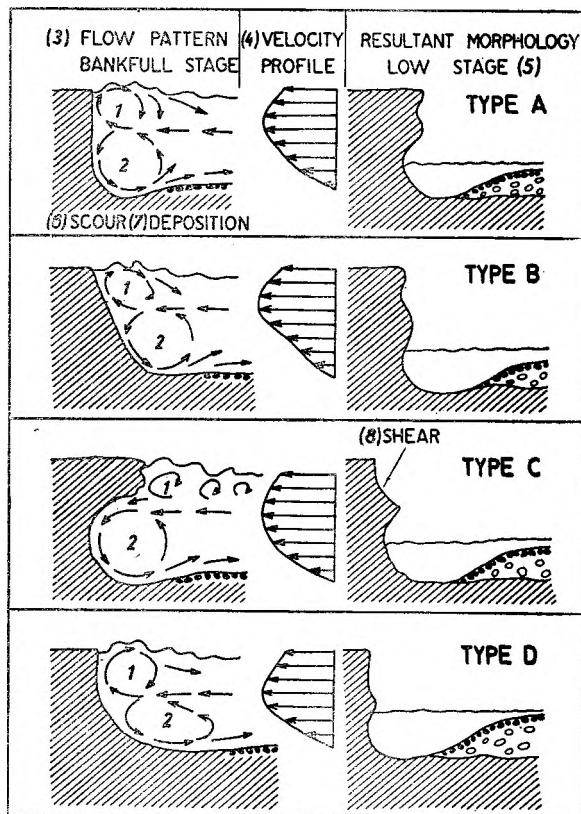
Fig. 8

Showing idealized structure of large, horizontal, spiral vortices (rollers) working along cutbanks of different morphology. Simplified from various study reaches on the Sudetic rivers. View is upchannel

Now it seems to be appropriate to add few words about the erosional processes themselves. River banks built up of cohesive soils (alluvial loams, clay, loamy sands) were eroded mostly through scouring, evulsion (pothole erosion), and corrosion including attrition and stripping (pl. V; *cf.* Rachocki 1974). The rate of lateral erosion was particularly large in a zone between mean stage and the lower limit of grass roots. The reason for this is perhaps complex. First, it is this zone in which the cohesive soil is especially weak owing to repetitive processes of drying and wetting as well as the activity of frost (Grabowska-Olszewska and Siergiejew 1977; Glazer 1977; A. K. Teisseyre 1979). Second, the rate of erosion of an alluvial bank is particularly large in the zone of water level or between a low stage and the stage corresponding to a mean annual flood. In this zone erosion is attributable to the activity of rollers and waves (fig. 8, 11).

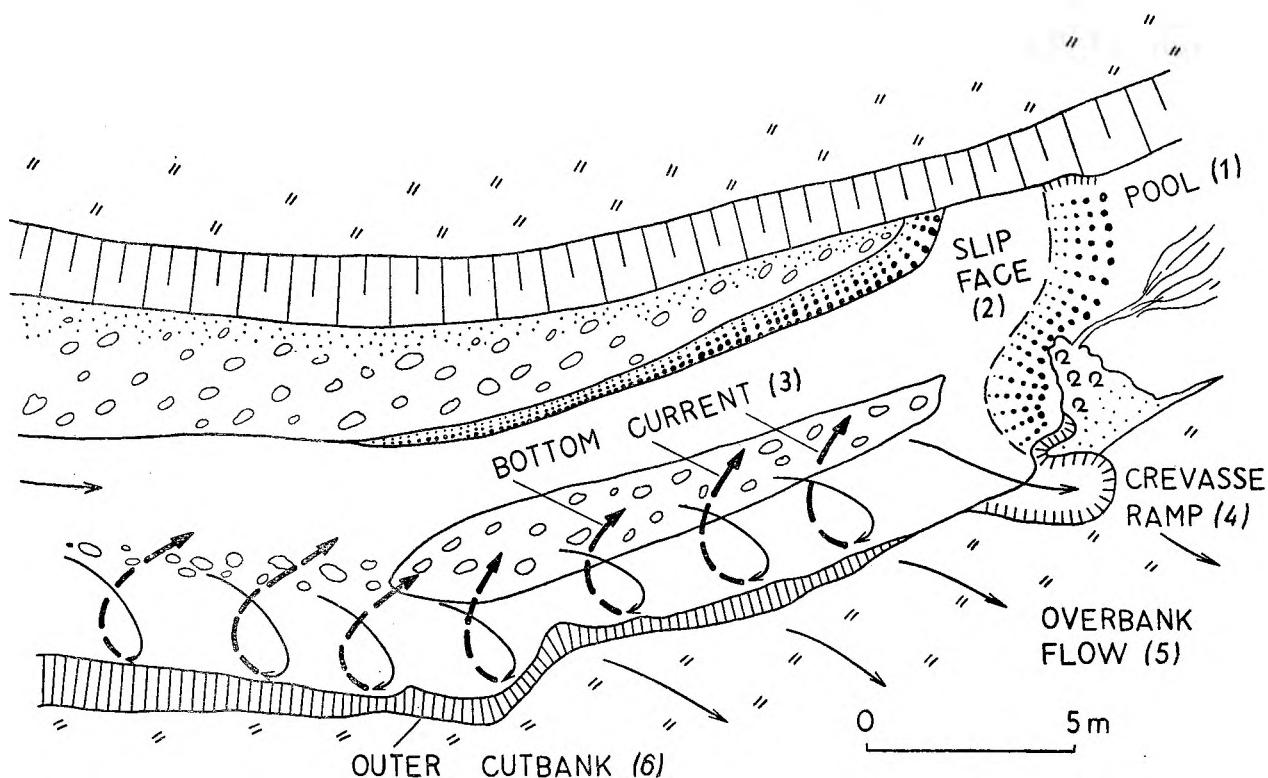
Fig. 9A

Structure of flood flow during the August 1977 flood near cutbank of the meander M-13, Złotna, site 4. Note normal roller. Mapping is by the author

The activity of the secondary circulation induced by the rollers may be also recorded in sedimentary structures like pebble fabric, for instance (fig. 9A; pl. IV, 4). Illustrated in the figure is a segment of the meander no. M—13. During the August 1977 flood the outer cutbank of the meander was intensely eroded by a normal roller. A secondary bottom current induced by the roller was able not only to scour the bank and stream bed but also to give a preferred orientation to coarse gravel deposited at the same time on a submerged mid-channel bar (pl. IV, 4). The orientation of imbricated flat cobbles from the bar is shown in figure 9B. It is evident from the diagram that the flat gravels

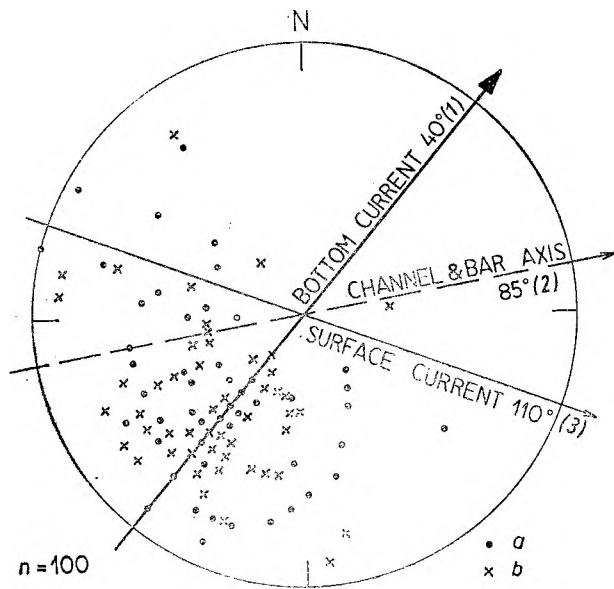
Fig. 9B

Point diagram of AB-planes of flat clasts (cobbles) from the mid-channel bar shown in figure 9A. Upper hemisphere
 a — measurements from the left half of the bar, b — readings from the right half of the bar. See text for details

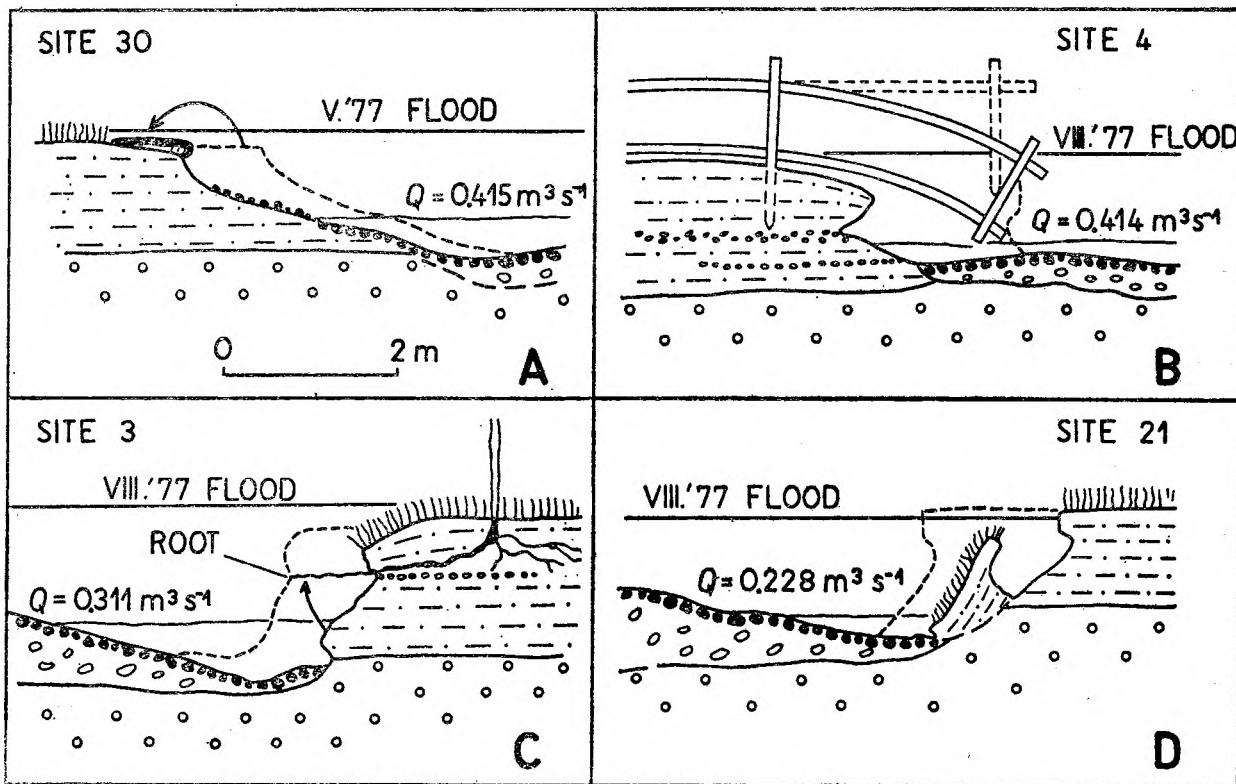
Fig. 10

Indirect evidence of lateral erosion along channel cutbanks, Złotna, Miszkowice Fan

The data listed in the appendix I came almost exclusively from direct field measurements of levelled cross-sections made by the author before and after the floods. However, there are also some indirect methods, which may help us to estimate the retreat of river banks in reaches not investigated prior to a flood (cf. Cooley *et al.* 1977). Four lines of indirect evidence are presented in figure 10. The first are the

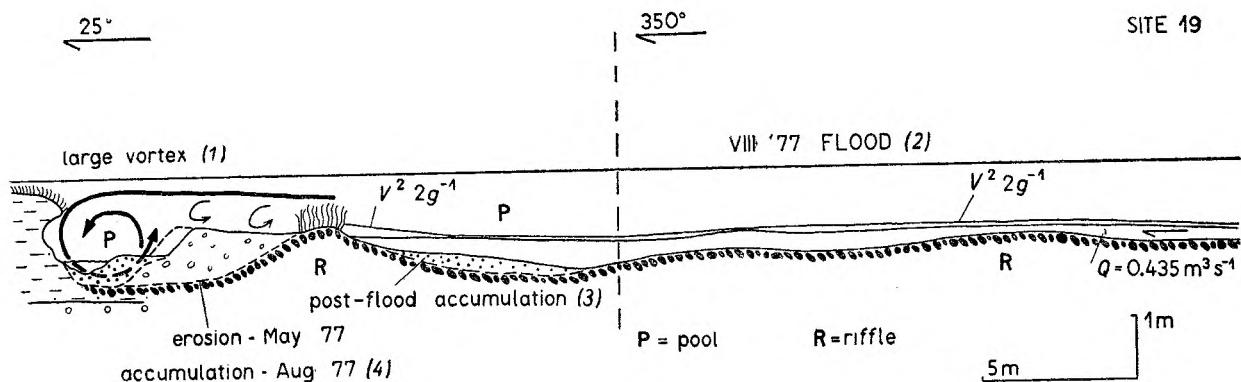
Fig. 11

Large stationary vortex (normal roller) near the outer cutbank, meander M-5, Złotna, site 19, as read from channel and bank morphology a year after the flood

In meander bends the rate of downward erosion depends on the intensity of flow perturbation which, in turn, is related to the geometry and roughness of the channel. It has been also found that the hydrodynamic thrust foster rapid erosion and that the rate of erosion is proportional to the angle of attack of the streamtube of maximum velocity (Friedkin 1945). The rollers generated at the river bank owing to the hydrodynamic thrust are very effective in scouring the channel bed and may be recorded both in bank and bed morphology (fig. 11).

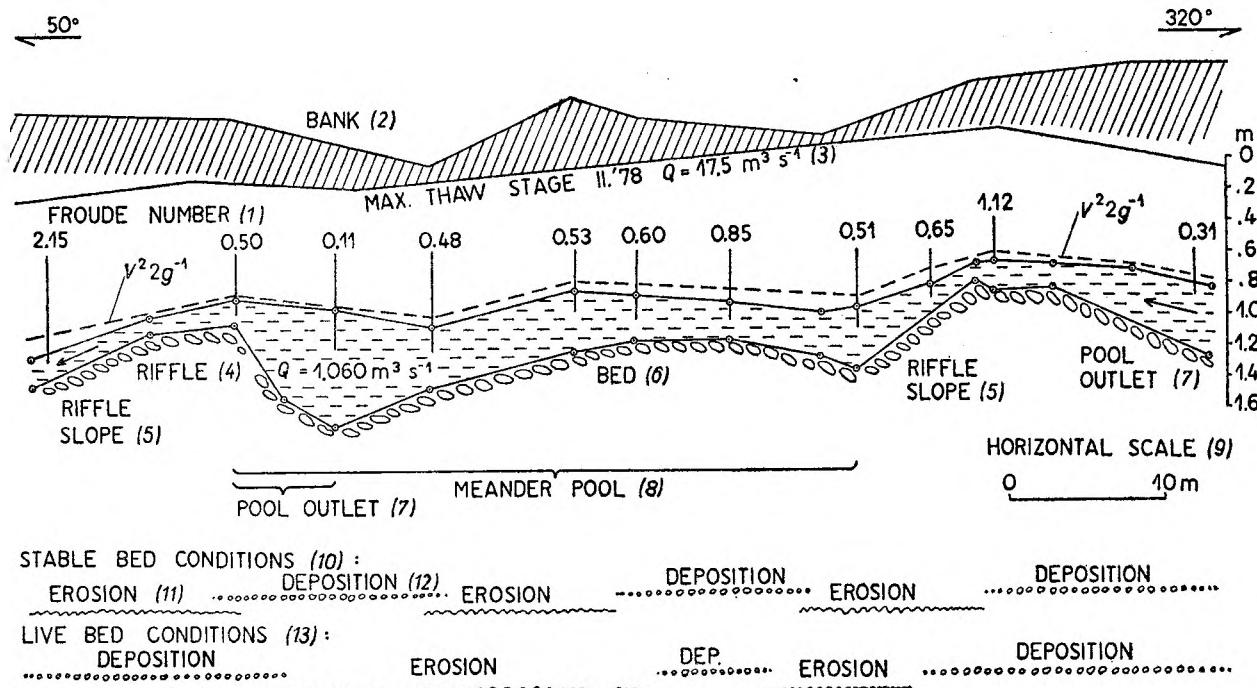
Fig. 12

Bed morphology, water surface, and velocity head in a meander bend, Bukówka study reach, meander B-1, River Bóbr

The character of flow was investigated in the field under conditions of different discharge and in places of different channel geometry. The most interesting results came from meander bends (fig. 12). During a mean discharge the flow became contracted over segments of the channel called here riffle slopes (A. K. Teisseyre 1977b). In such places the velocity head attained the highest position, the flow velocity, the Froude number and the bed shear stress were at a maximum. These were the places in which potential energy of the stream changed to kinetic energy. Large kinetic energy induces turbulence at the boundary and thus results in downward erosion (Sundborg 1956; Klimek 1972) being realized mostly through eluviation of the gravelly bed. At the riffle slope-pool junction the hydraulic jump commonly occurred with the resultant energy dissipation and strong downward erosion. The result is the so-called backward erosion on riffles — a tendency for the riffle slopes to retreat upchannel (pl. IX, 4). At the same time the meander pools acted as stilling basins. These were areas of flow expansion and a decelerating non-uniform flow. Within the pool shown in figure 12 the effects of efflux and flow separation were noted in the upper part of the pool, while the backwater effects and a decelerating flow were typical of its lower portion. The

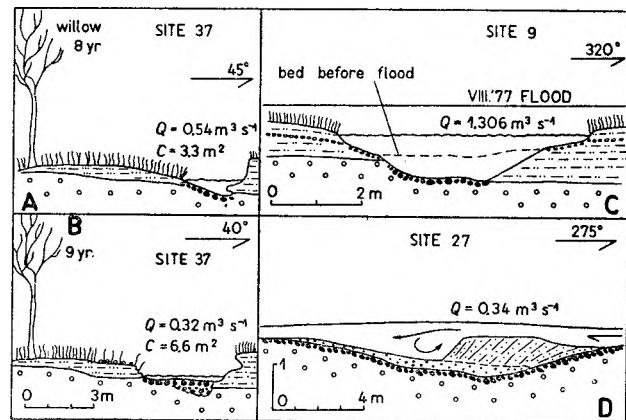
Fig. 13
Direct and indirect evidence of downward erosion occasioned by flood discharge

A, B — direct evidence of scour — levelled cross-sections before (A, June 1977) and after the August flood (B, September 1977). Cross-section A shows channel morphology after the May flood — note bank niche in the deepened channel. C — channel capacity. C, D — indirect evidence of scour: relics of original bed from before flood (C, September 1977) and thick recent accumulation of a microdelta-type (D). Thickness of the microdelta is almost equal to the depth of scour. Levelling is by the author

The rate of downward erosion can be best established using levelled cross-sections made before and after a flood. However, there are also some indirect methods as hanging or undermined designs, evulsion troughs (potholes), thick post-flood deposits accumulated in the form of a microdelta and relics of a bed from before a flood (fig. 13). Figure 13A and B illustrates also the geomorphologic effects of the two floods of

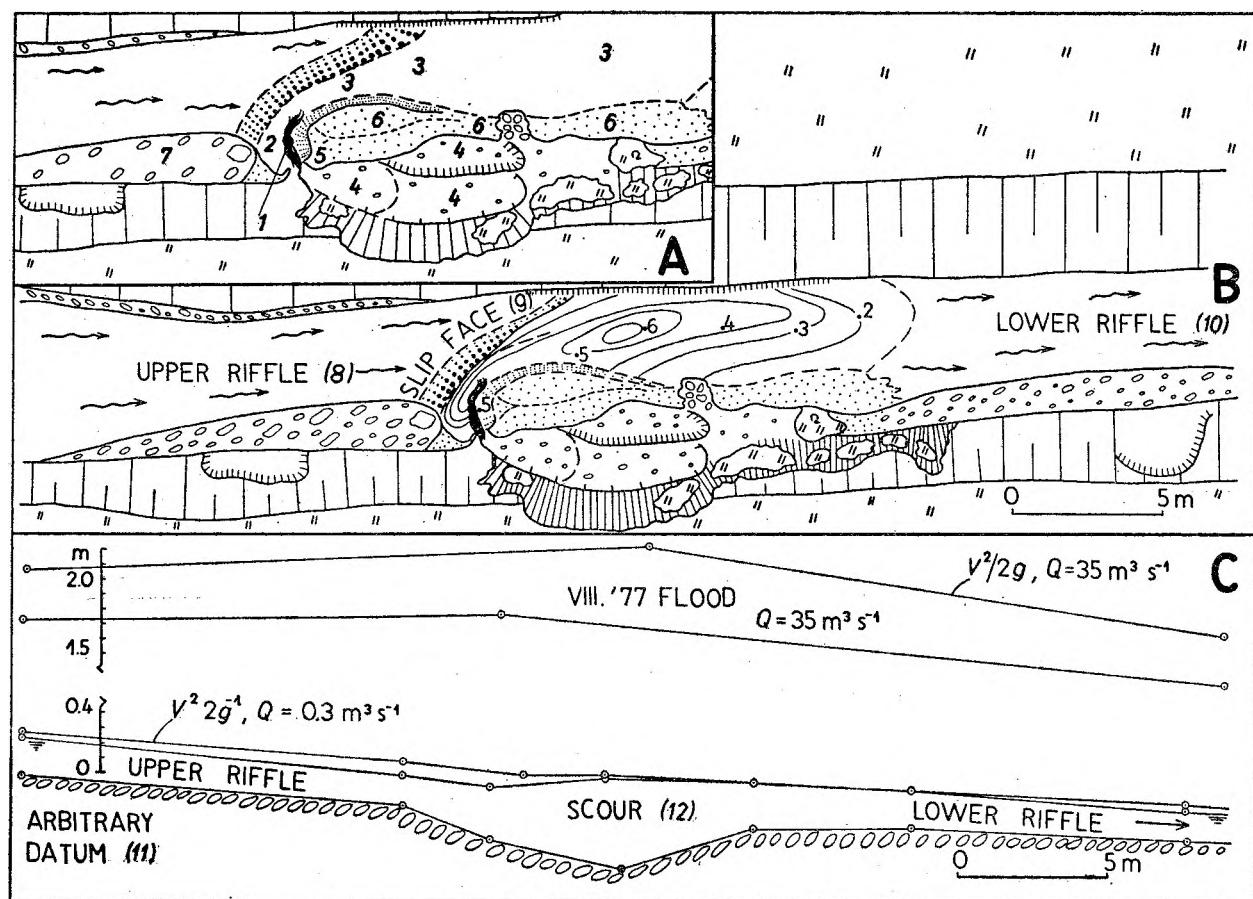
Fig. 14

Scour around a large obstacle, site 2. See text for details. Mapping and levelling is by the author. Scour in figure B is contoured at 0.1 m intervals

The large scours are commonly asymmetrical features for they are connected genetically with large obstacles occurring particularly at a channel bank like old trees, for instance. A large scour originated during the August flood in the straight segment of the Złotna (site 2) is shown in figure 14. The following elements can be distinguished here (fig. 14A): The obstacle — a tree trunk (1) — together with a small plant jam superposed on it, the frontal scour (2), the lateral scour or trough (3) with its right-bank counterpart in the form of shallow wash-outs (4), the back scour (5), which originally was much longer extending downchannel over a distance corresponding in length to the large sediment shadow (6), which is here a post-flood feature. An additional feature, which commonly develops in front of such large scours, is the elongated frontal bar (7). This may occur either at the channel bank (a channel-edge bar) or along its axis (a mid-chan-

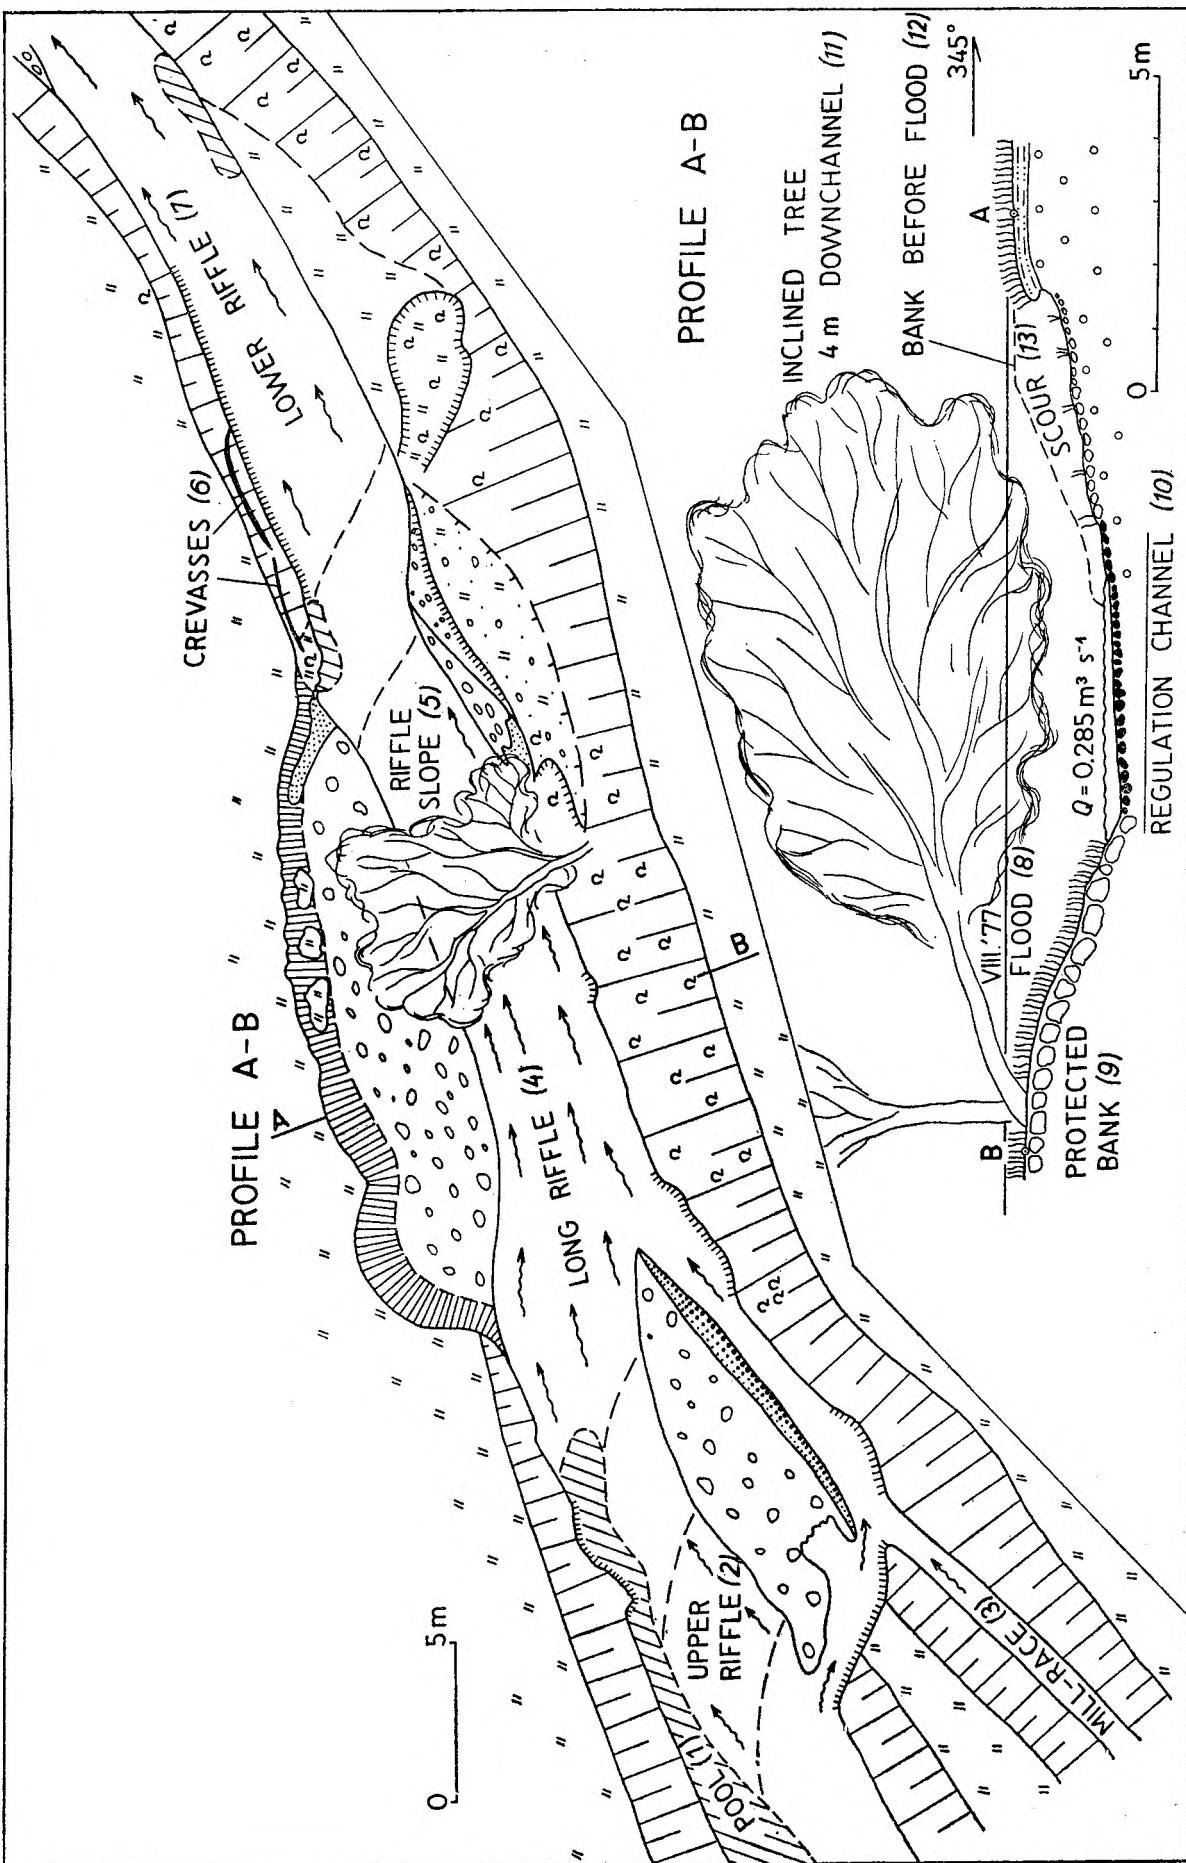
Fig. 16

Scour around a sluicegate-like obstacle, site 5. See text for details. Mapping and levelling is by the author

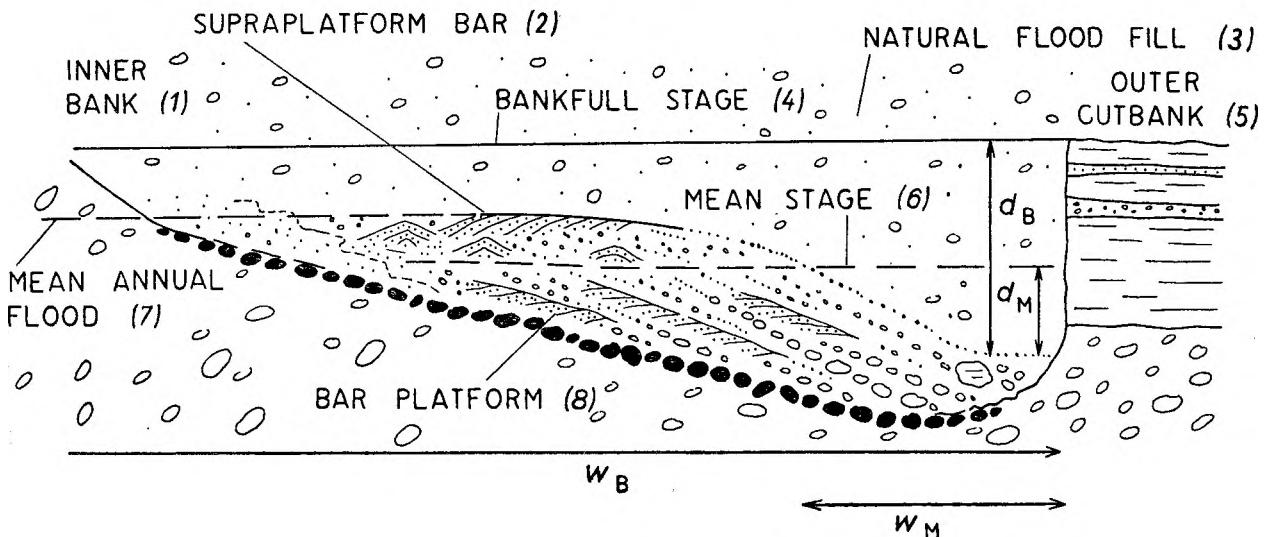
Fig. 18

Paleohydraulic interpretation of a frozen meandering channel. Synthetic drawing based on observed paleochannels in the Quaternary deposits, Central Sudetes

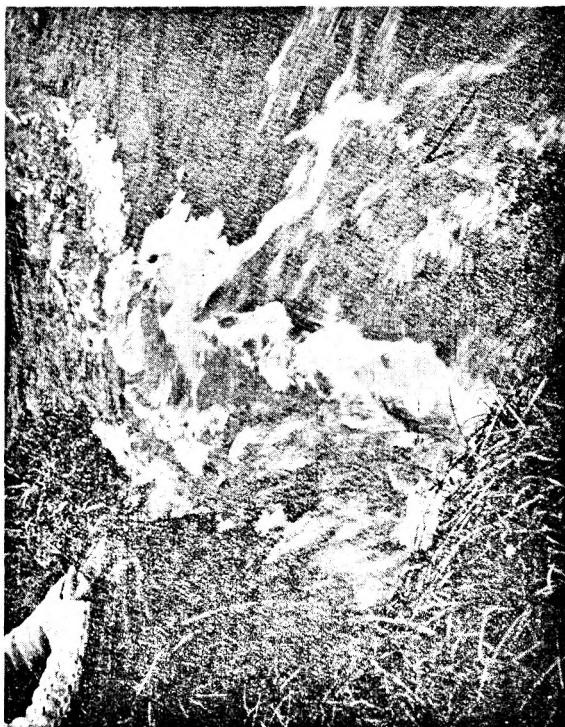
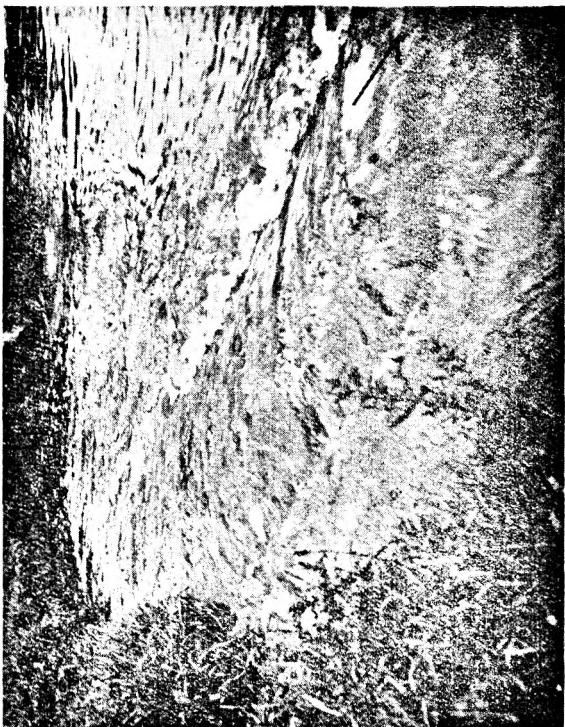
2. Reverse roller, growing stage. Location as above. Note small, vertical, secondary, vortexes
Odwrotny wir śrubowy, stadium wzrastające. Lokalizacja jak wyżej. Widoczne są małe, wtórne, pionowe wiry

3. Reverse roller, advanced stage. Location as above
Odwrotny wir śrubowy, stadium zaawansowane. Lokalizacja jak wyżej
4. Reverse roller just before “bursting”. River Bóbr, Bukówka study reach, meander B-3. August 23, 1977
Odwrotny wir śrubowy, stadium poprzedzające “pęknięcie” wiru. Bóbr, odcinek badawczy w Bukówce, meander B-3, 23 VIII 1977

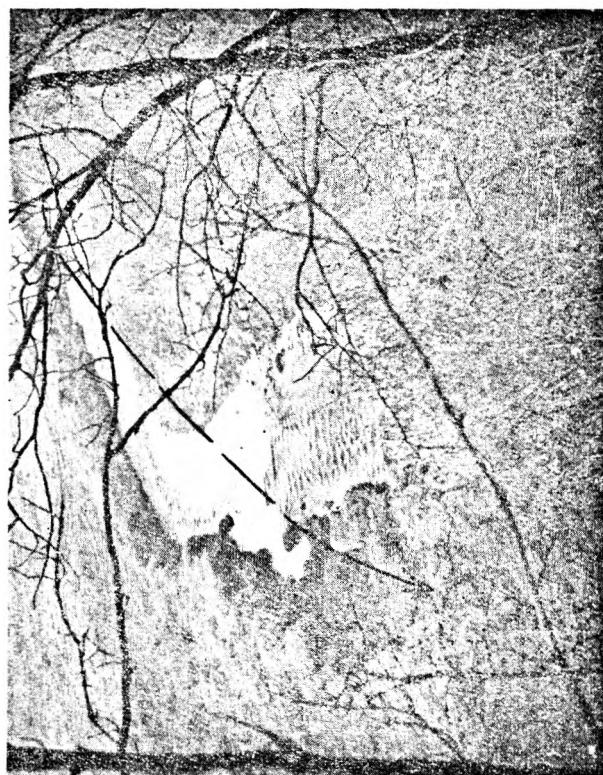
4. River Złotna, meander M-13, site 4. Note the mid-channel bar (same as in fig. 9A) and the meander pool (indicated by arrow) scoured by normal roller. May 1978
Rzeka Złotna, meander M-13, punkt 4. Widoczna jest łacha śródkorytowa (ta sama co na figurze 9A) oraz przegłębienie meandrowe (strzałka) wymyte przez normalny wir śrubowy o osi poziomej. Maj 1978

Układ przepływów wtórnych zaindukowanych przy dnie przez wiry o osi poziomej może być też utrwalony pod postacią struktur sedymentacyjnych, na przykład przez ułożenie żwirow plaskich. Przypadek taki ilustruje figura 9, na której pokazano schematycznie układ prądów wtórnych wywołanych przez duży, prawoskrętny (normalny) wir śrubowy o osi poziomej. Prąd denny zaindukowany przez ten wir spowodował bardzo wyraźne ułożenie otoczaków płaskich leżących na łasze śródkorytowej (fig. 9B; pl. IV, 4). Podobne struktury w formie „zamrożonej” są znane także z osadów kopalnych (A. K. Teisseyre 1975b).

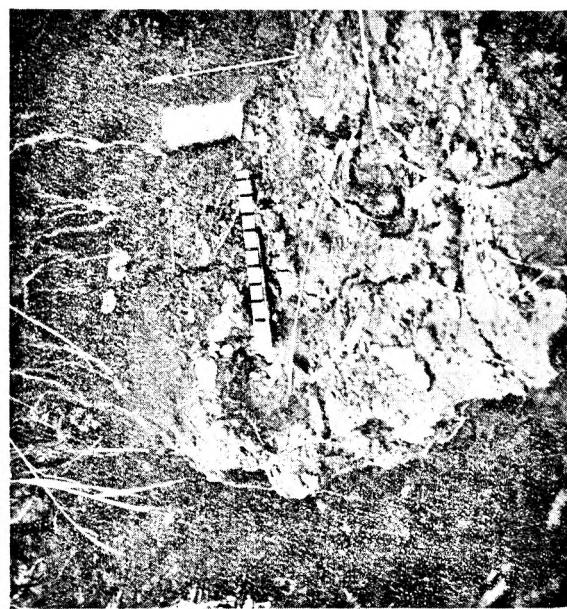
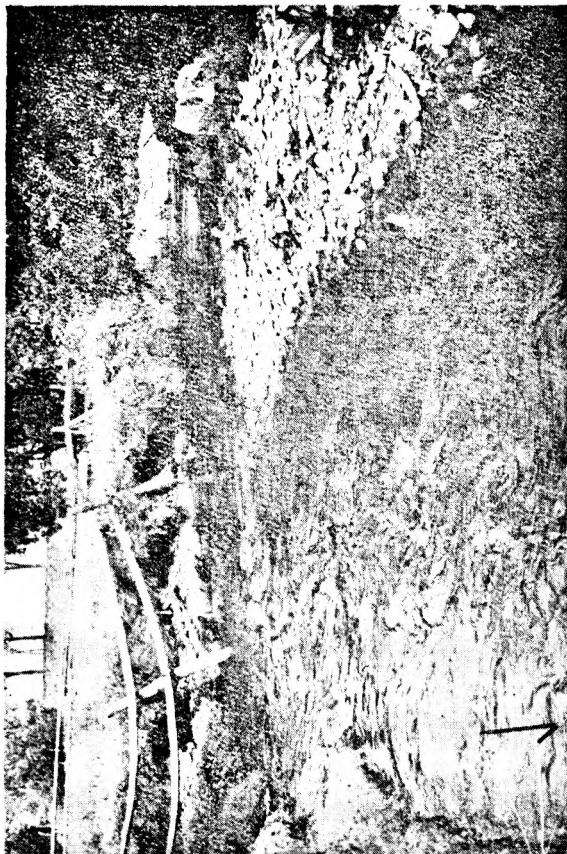
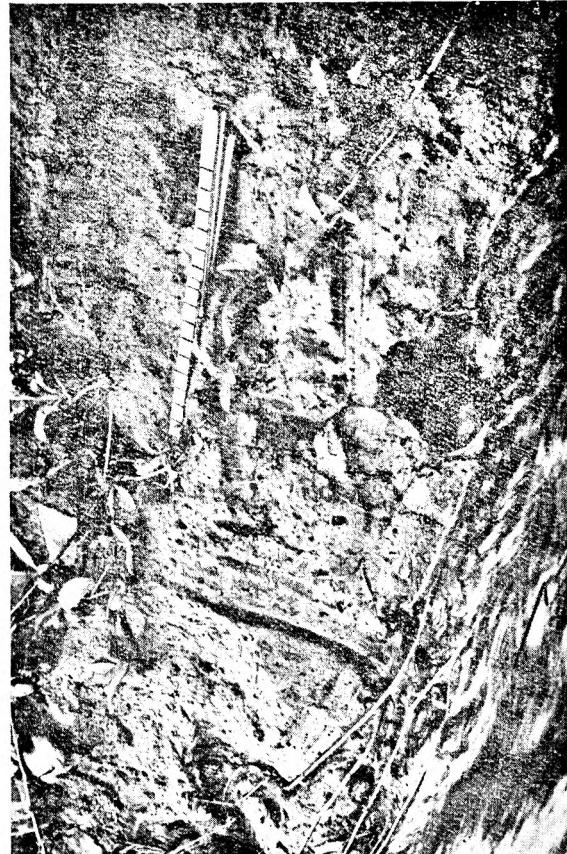
2. A fragment of outer cutbank, Złotna, site 4. The retreat of the bank during the May flood is indicated by the nail
Część podcinanego brzegu zewnętrznego, Złotna, punkt 4. Cofnięcie brzegu w czasie powodzi majowej wskazuje gwóźdź
3. Morphology of active cutbank after the May flood, Złotna, site 37. Note horizontal and vertical grooves produced by cobbles and boulders dragged along the bank during the flood. 2-cm scale on the rule
Morfologia aktywnego, podcinanego brzegu po powodzi majowej, Złotna, punkt 37. Widoczne są poziome i pionowe bruzdy wywołane przez grube żwiry wleczone w czasie powodzi wzdłuż brzegu. Na całowce skala co 2 cm
4. Cow-made erosion of a loamy bank, Złotna, site 33. June 1977
Erozja brzegu wywołana przez krowy, Złotna, punkt 33. Czerwiec 1977

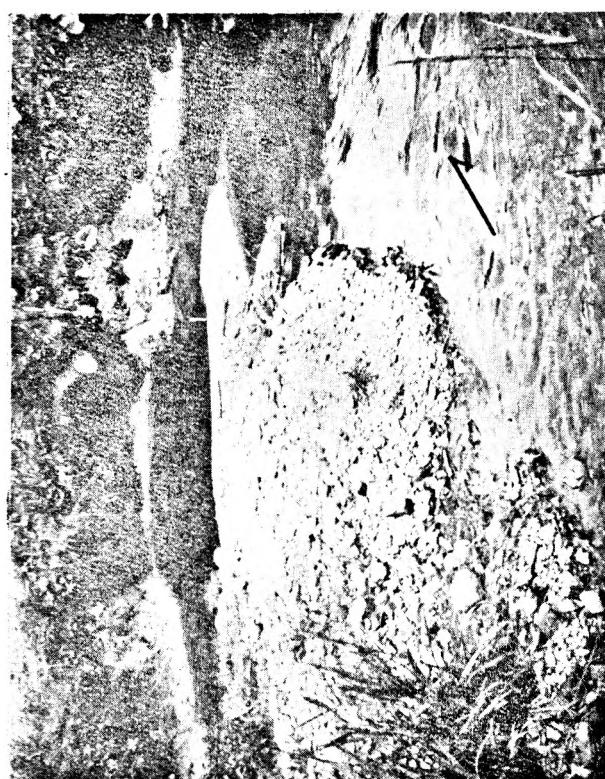
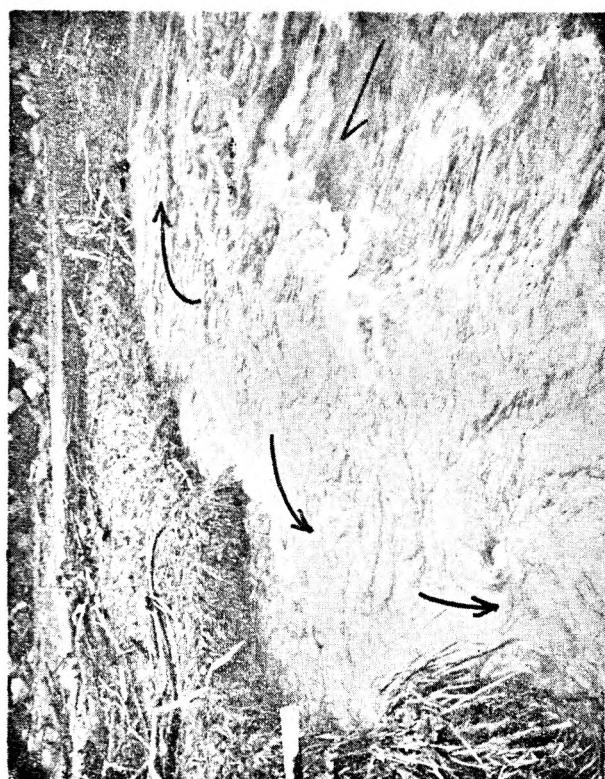
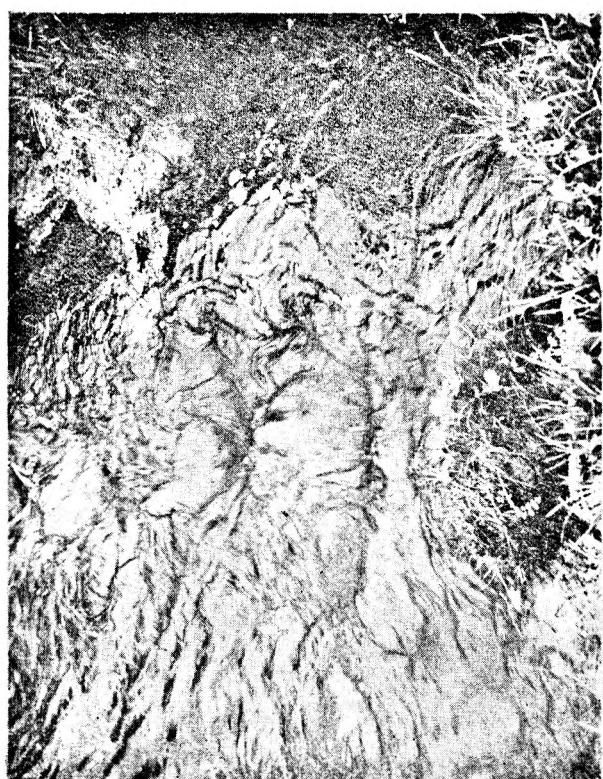
3. A mushroom-like eddy (a local displacement of water terminating at the surface in a nonrotating boil of Matthes). Location as above. August 23, 1977
Wir wstępujący o charakterze grzyba. Lokalizacja jak wyżej. 23 VIII 1977

4. Bank niche originated in the place shown in photo 3. Note angular blocks of alluvial loam and loamy balls. Location as above
Nisza brzegowa powstała w miejscu pokazanym na fotografii 3. Widoczne są kanciaste bryły gliny aluwialnej i pojedyncze toczeń ce. Lokalizacja jak wyżej

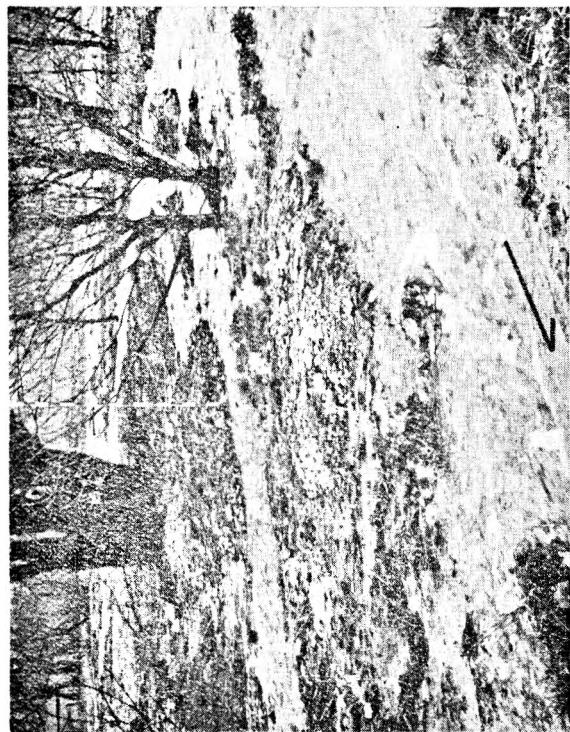
4. The same place a year after the flood. Note erosional remnants of the point bar and the chute channel. August 1978
To samo miejsce rok po powodzi. Widoczne są erozyjne pozostałości łachy meandrowej oraz koryto przelewowe. Sierpień 1978
