# PRELIMINARY RESULTS OF GEODETIC MEASUREMENTS IN THE INOWROCLAW SALT DOME AREA, CENTRAL POLAND

Szczerbowski, Z., 2004. Preliminary results of geodetic measurements in the Inowrocław salt dome area, central Poland. *Annales Societatis Geologorum Poloniae*, 74: 319–324.

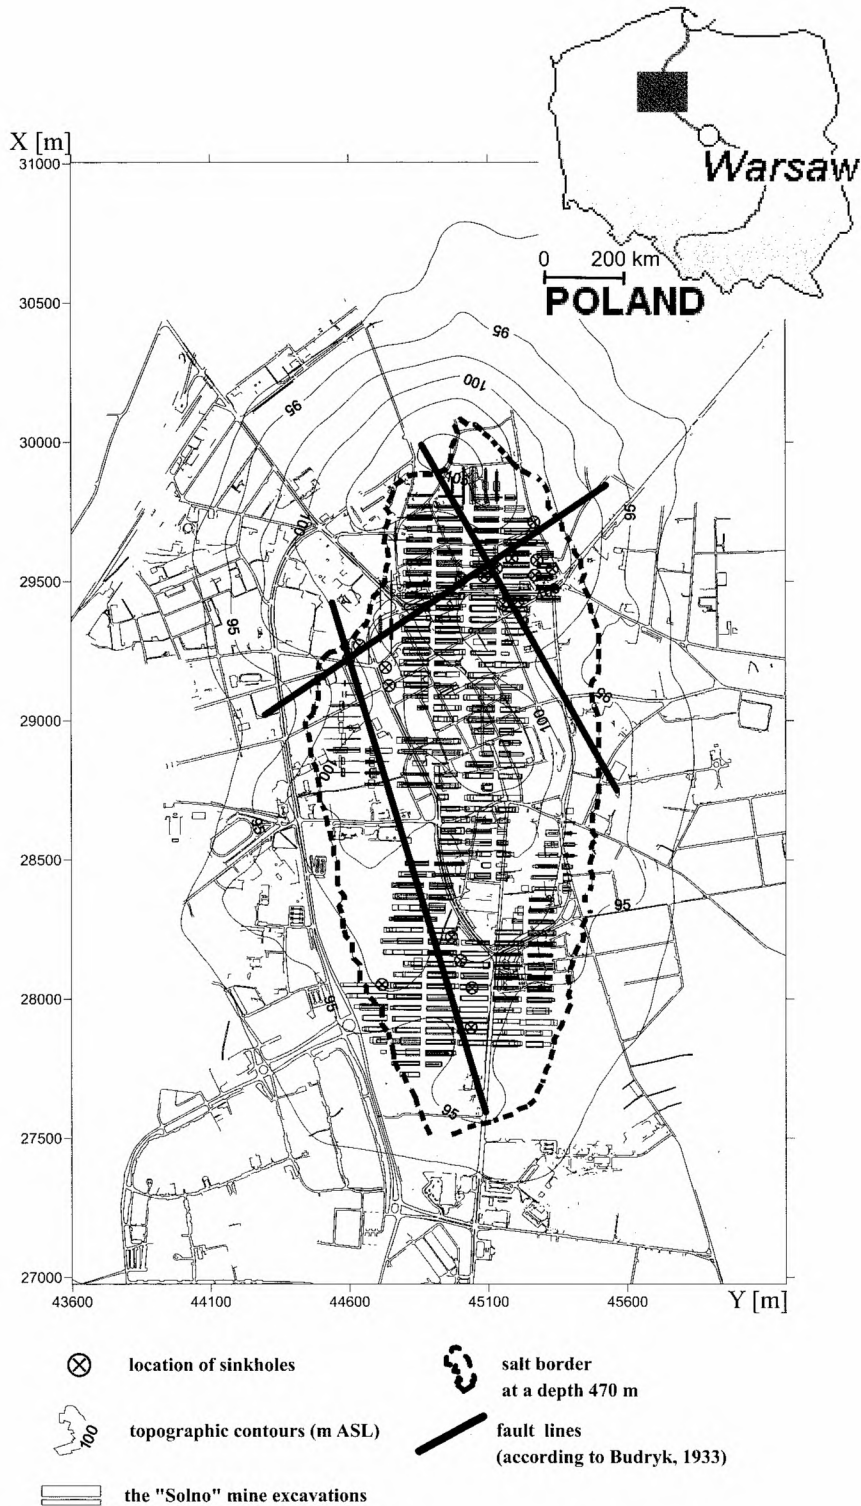
Fig. 1. Location map of the Inowrocław salt dome area (coordinates are in a local geodetic system)

tioned by Budryk (1933) and Poborski (1957). Budryk (1933), by using old observations conducted during shallow mining, described the system of faults determining the underground water circulation, and the structure of sinkholes which have been formed without any relation to mining activity. These faults intersect one another in the northern part of the dome (Fig. 1).

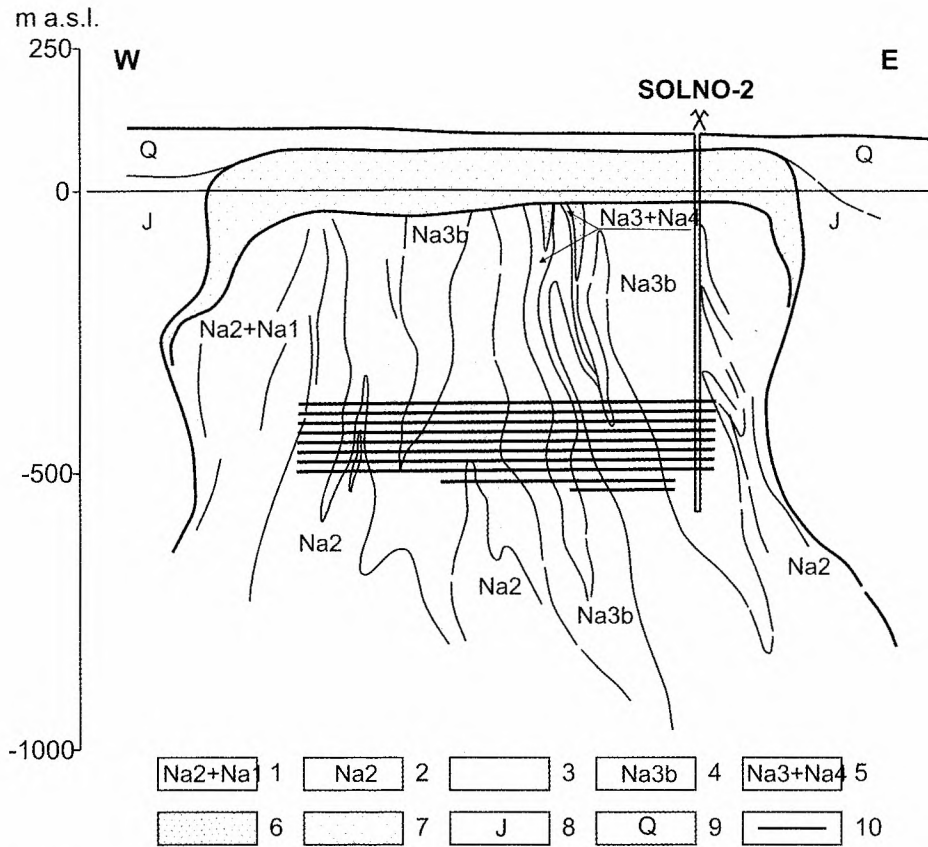
**Fig. 2.** Tectonics of the Inowrocław salt dome (after Poborski, 1957; and Bujakowski, 1986). 1 – The Older Rock Salt with a possible occurrence of the Oldest Rock Salt, 2 – the Older Rock Salt, 3 – the Younger Rock Salt (lower part), 4 – the Younger Rock Salt (upper part), 5 – the Younger and the Youngest Rock Salt, 6 – the Youngest Rock Salt, 7 – cap rocks and anhydrite, 8 – Jurassic, 9 – Quaternary, 10 – The Solno mine's levels

The salt dome geometry in plan view resembles an ellipse, 3 km by 1 km across. It is located as a salt dome at Góra on a morainic plateau that is free of convex marginal forms. Both the eastern and western sides of the salt structure are steep or even upright (Fig. 2). The surface of the salt roof is situated 120–190 m below the ground surface and it is covered by cap rocks, 50–180 m thick (Fig. 2).

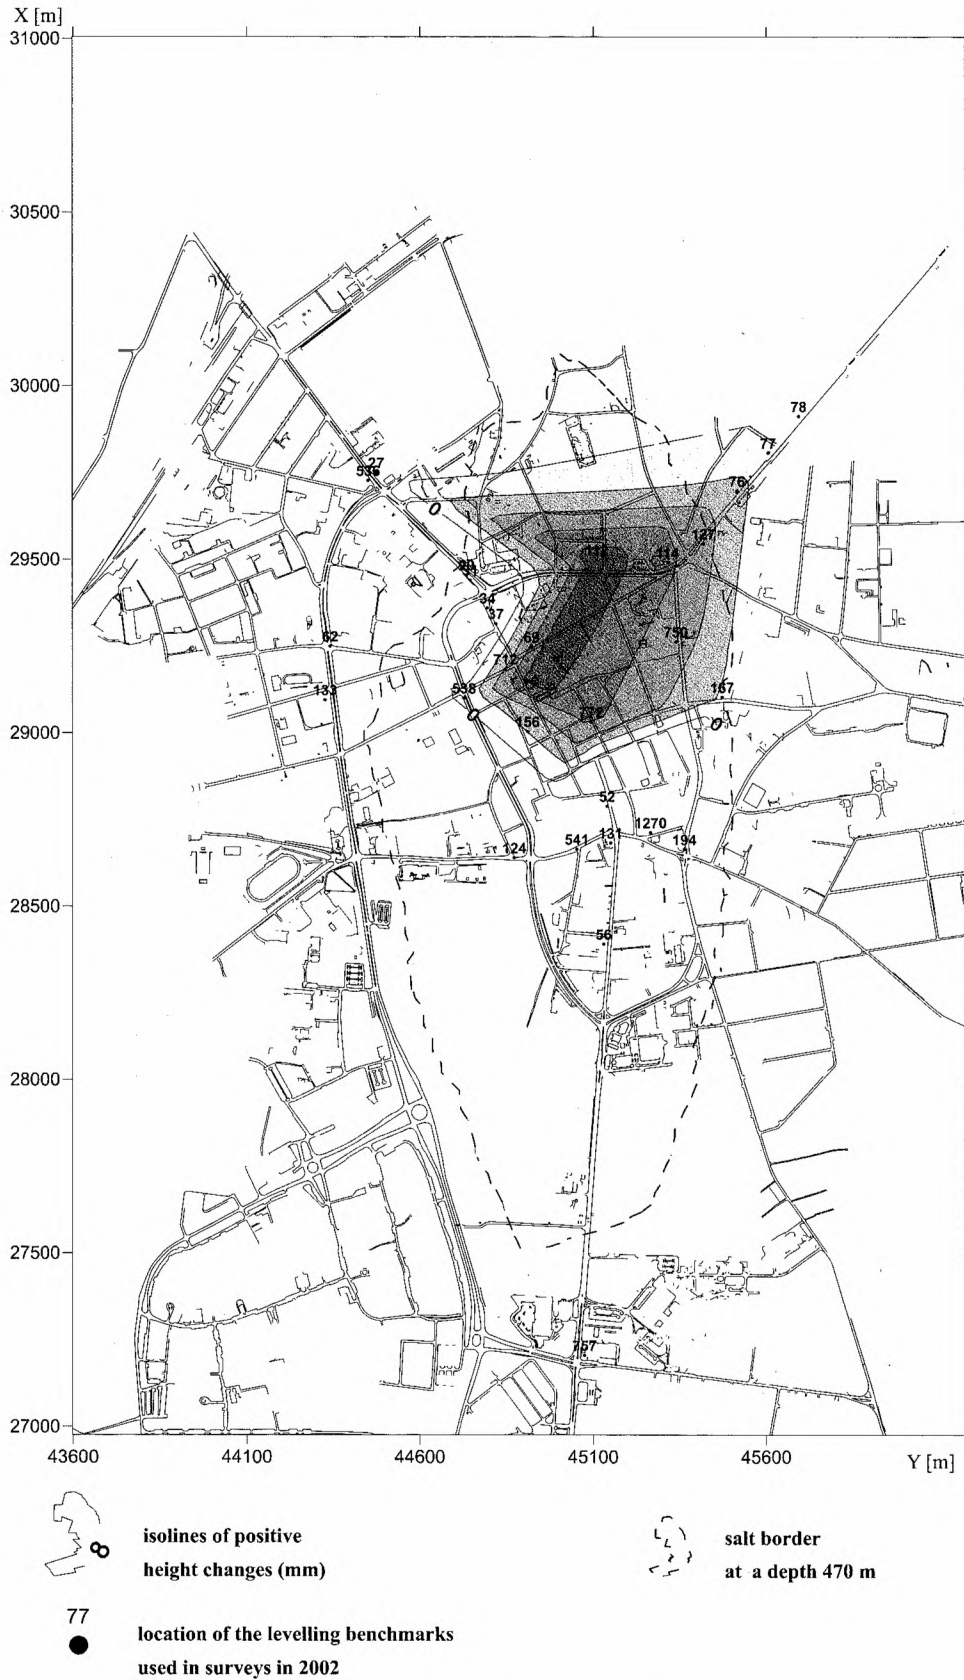
Fig. 3. Provisional border of the salt dome and the area of detected positive height changes

Precise levelling observations, conducted for decades every 1–2 years, have shown a good accuracy. In 2002, after 7 years break (currently after the mine closed down the measurements are not carried out), the levelling observations were conducted by AGH-UST research team measuring selected (about 30) benchmarks. One third of them demonstrated positive height changes in the relation to both 1992 and 1995. Even though the changes were slight (the maximum value of uplift was 10 mm in the period of 10 years), the estimated trend of uplift and its spatial distribution eliminates its randomness. The uplifted area extends behind the horizontal range of the Solno mine excavations. Fig. 3 demonstrates the location of the detected positive height changes.

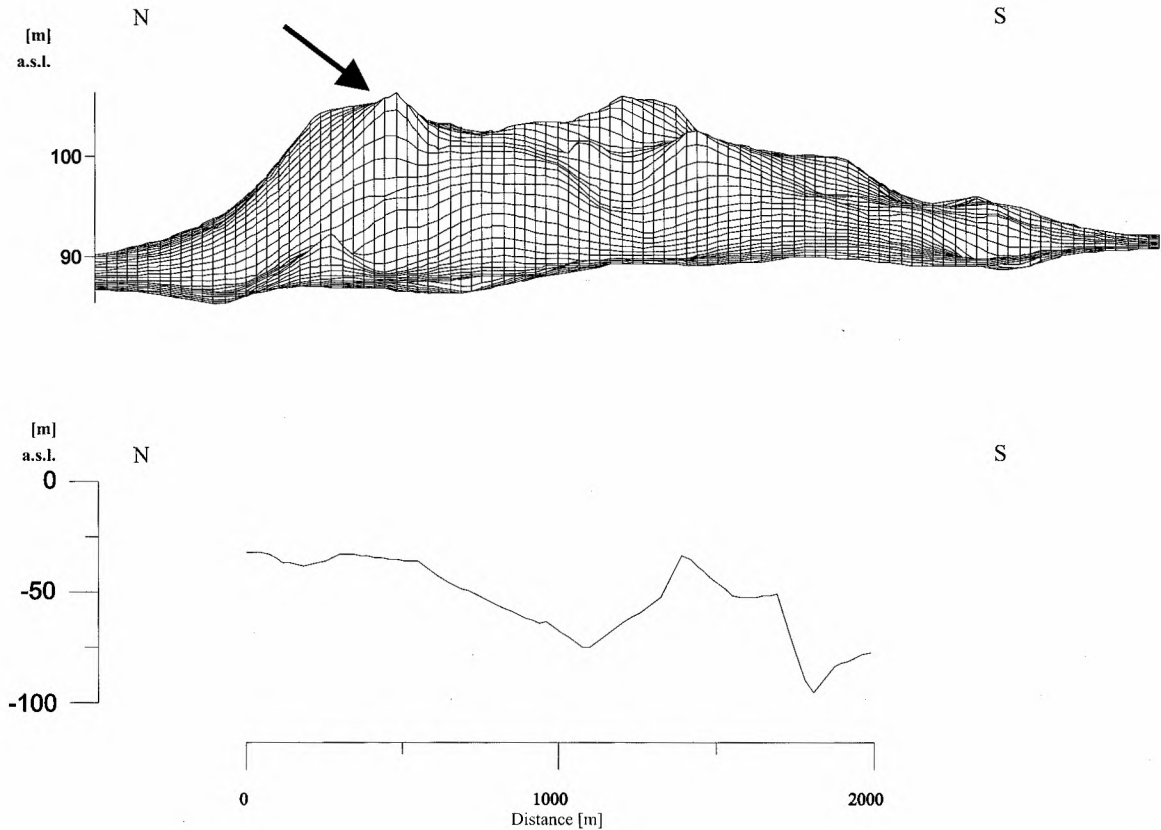
**Fig. 4.** The area of positive height changes (arrow) shown in a perspective view of the topography of the Inowrocław area and N-S profile through the salt structure (in the bottom part of the picture)

The salt dome morphology demonstrates a similarity to the ground surface topography, which is consequently related to the registered uplifts; the area of the maximal uplift is situated on the highest part of the hill, wherein the elevation of the salt structure is the highest (Fig. 4). Moreover, the area is historically known as a place affected by sinkhole deformations, resulting from intensive karst process (Budryk, 1933; Poborska-Młynarska, 1984). Maximal values of detected uplifts can be higher than the measured ones, because the survey was carried out only at selected points, and
